German Long-Term Experience with Reinforced Embankments on Soft Subsoil: Performance and Durability

ABSTRACT: Two projects of embankments on soft subsoil with high-strength basement reinforcement are shortly described. Started in 1981 and 1986, respectively they belong to the first one's using preloading plus reinforcement for autobahns and highways in Germany. Site conditions, construction stages, measurement data and evaluation are presented, including long-term reinforcement strain measurements until 1998. The geotextiles are still under tension. In 1995 high-tenacity polyester woven was exhumed from underneath the first embankment and analyzed for evaluation of durability. Important results are reported, confirming negligible loss of strength in 14 years. In conclusion, findings and recommendations for focal points of design, long-term reinforcement behavior and durability are summarized.

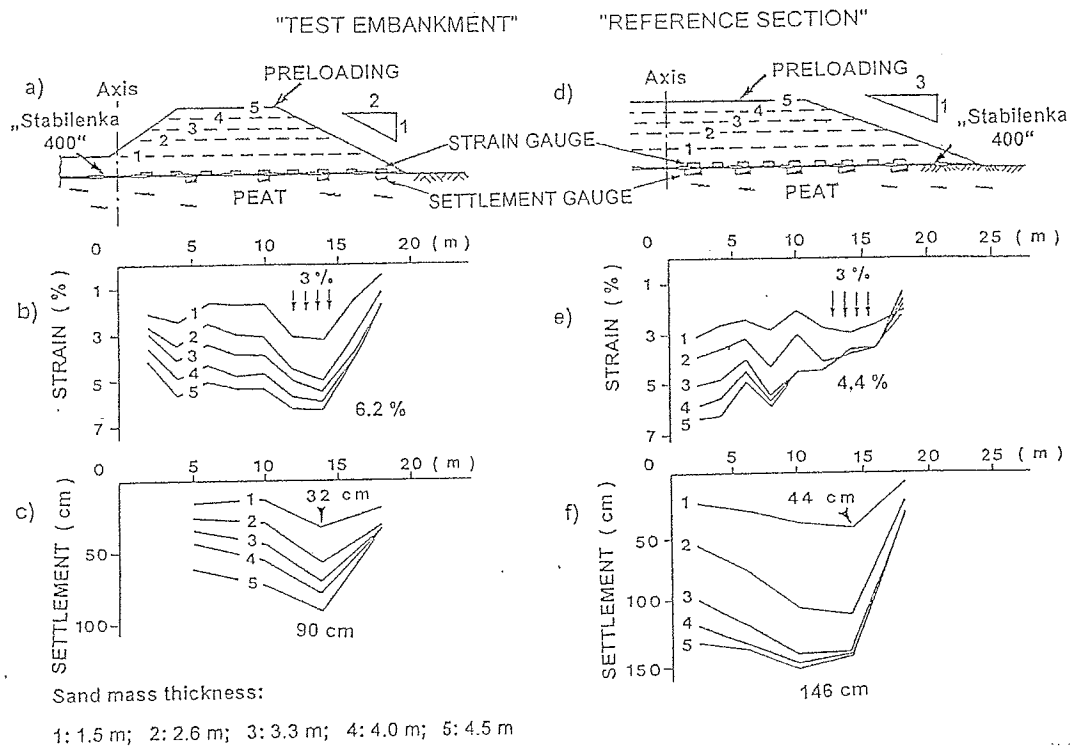
Figure 3. Grossenmeer: construction stages, settlements and strains

Settlements, pore water pressure, inclination and groundwater level of the subsoil were measured. The strain measurements were performed on, in total three cross sections, two of them in the 'test embankment' and one in the 'reference section'. In each case 9 strain gauges were installed at 2 m space. Additionally, settlement gauges were placed near the strain gauges (Figure 3 a, d).

The most important results are depicted in Figure 3 a, b, c for the 'test embankment' and in Figure 3 d, e, f for the 'reference section'. Note, that embankment material, single layer thickness, height (4.5 m) and reinforcement are the same.

In Figure 3 b, c the graphs show the development only within the first 4 days (height from zero to 4.5 m). After that the increase in strain became less and, after 2 months, came almost to a halt (not shown). In the subsequent 25 months the strains asymptotically came up to a maximum final strain of about 7% below the slope and 6% below the center of the embankment (not shown).

In Figure 3 e, f the graphs show the processes within around one year (height from zero to 4.5 m stepwise). The line with the number 1 corresponds to the 4th day (1.5 m sand), and with the numbers 2 to 5 to the 30th day after placing of the respective sand layer, at nearly constant time intervals.

Note, that in Figure 3 d, e, f only the period from June 1987 to June 1988 is depicted. After that in Autumn 1988 the height of the 'reference section' was increased to 6.5 m to compensate the high settlements, and was reduced again just in Spring 1990 (Figure 4).

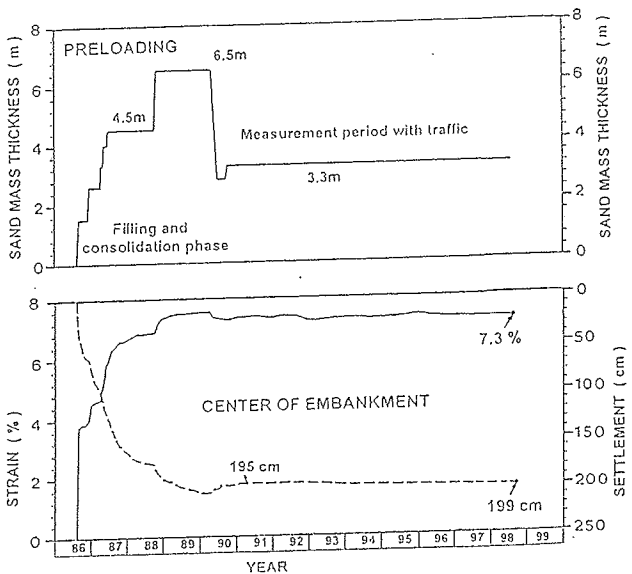
Figure 4. Variation of load, strain and settlement in the Grossemeer 'reference section' (1986 to 1998).

So far, at the center of the embankment, maximum strains between 6.8% and 7.6% and maximum settlements of the soft subsoil of between 190 cm and 205 cm have been measured. The strains presented in Figure 4 from commencement of construction in July 1986 until July 1998 remained practically unchanged after removal of the pre-loading height and opening of the highway to traffic in October 1990.

It was observed during uncovering, that the woven was still under tension before cutting. A considerable effort was necessary to lift up the edge of the woven by a shovel (Figure 6). This observation corresponds to the strains under the Grossemeer 'reference section', which indicate considerable tensile forces until

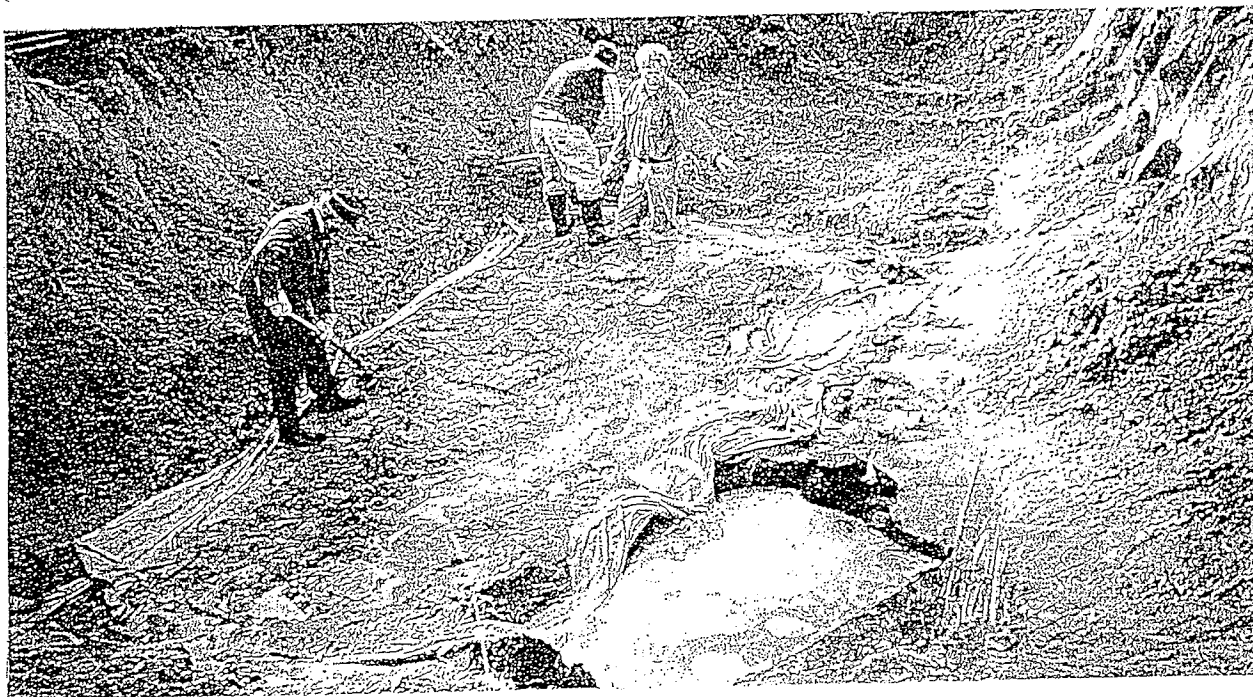
Figure 5. Rübke: exhumation of the high-strength woven (Stabilenka® 200) after 14 years

In September 1995, around 120 m² of the high-strength woven were exhumed from the embankment base after 14 years in use. The entire geotextile was lying below the terrain in the peat and groundwater due to settlements. By an excavator, embankment parts were removed down to the woven, from the slope to the center of embankment. At the beginning, it was possible to remove the remaining sand by hand (Figure 5). Due to the rapid rising of water, it was unavoidable to pull out and up most of the woven directly by the excavator. Thus, abrasion and damage of the fabric could not be fully avoided.

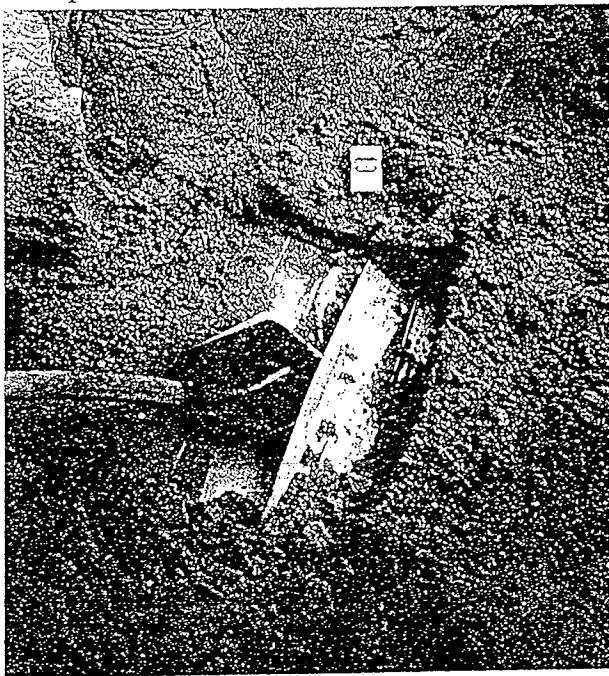
Figure 6. Rübke: the woven being still under tension after 14 years.

today also (Figure 4). Discoloration of the fabric due to contact with the rotted grass and the peat were clearly visible. In some places, grains of sand had penetrated its structure.

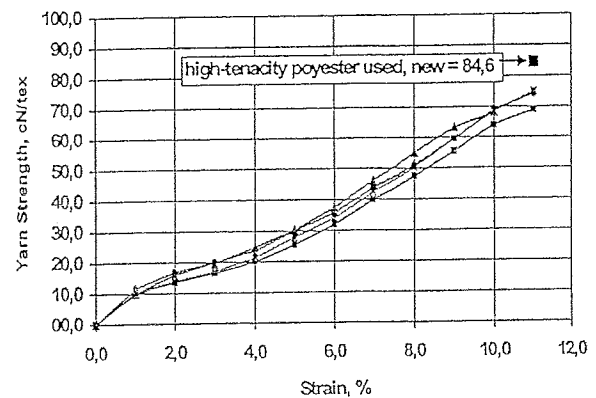
Figure 7. Specific yarn strength after 14 years in soil under groundwater level for the four different sampled areas according to DIN 53834, T 1.

The results of yarn tensile tests form a better criterion for evaluation of strength loss due to environmental effects than the wide-width strip tests. Damage caused by installation, compaction and (in this case) removal and exhumation, and sand-grain inclusions in the woven structure has a less pronounced influence on the cleaned single yarn (although it can not be eliminated). The graphs in Figure 7 show the stress-strain behavior of the exhumed yarns. Each curve represents the average of 15 tests per area.

The specific yarn strength of the 'virgin' (brand new) high-tenacity polyester used (CEG < 27

The comparison of the percentage terms described above (weaving, compaction and exhumation) with the registered total loss of yarn-strength of about 17% results in 0% to 3% loss of strength due to environmental effects in this case.
