Some case studies of geosynthetic solutions dealing with landslides and unstable slopes in north Algeria

Rabah ARAB¹, Romain DURAND¹, Hakim BOUMEZOUED², Nabila MAZANI³, Mohamed FOURA⁴, Rachid KEBAH⁵

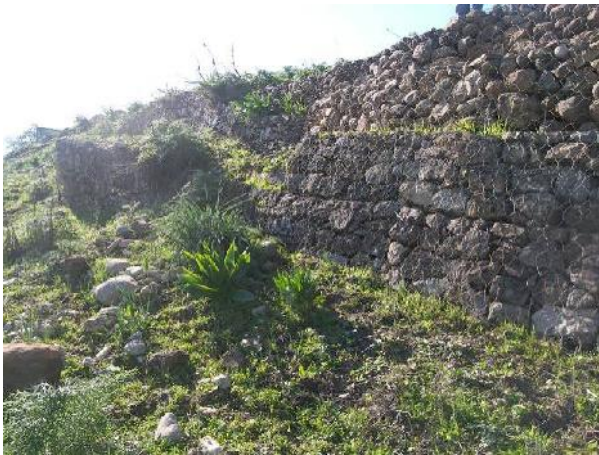
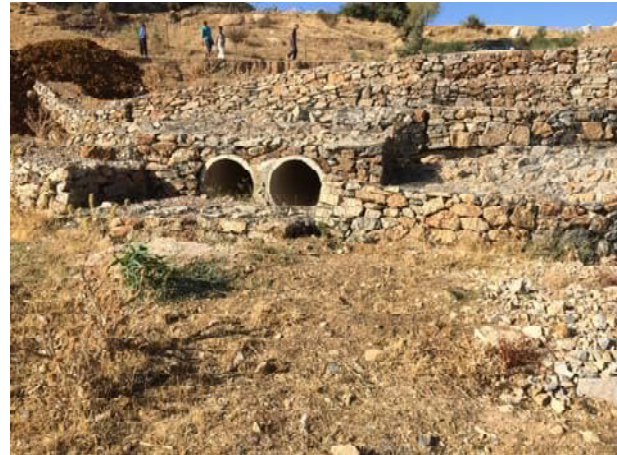
Figures 1 et 2. Examples of gabion toe

The figures 1 to 4 show examples of the instabilities treatments build as empirical solutions, which often doesn't solve the problem long-term.

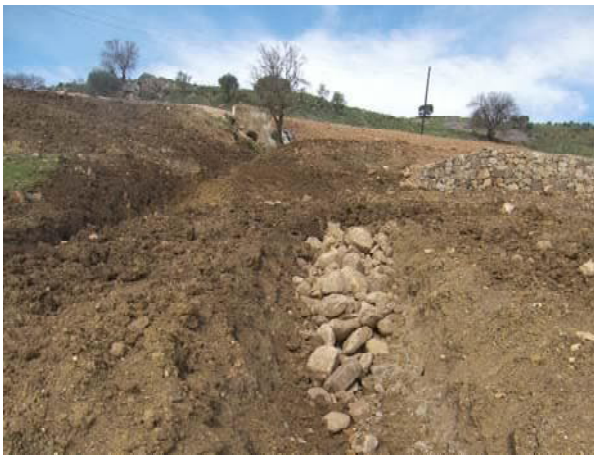
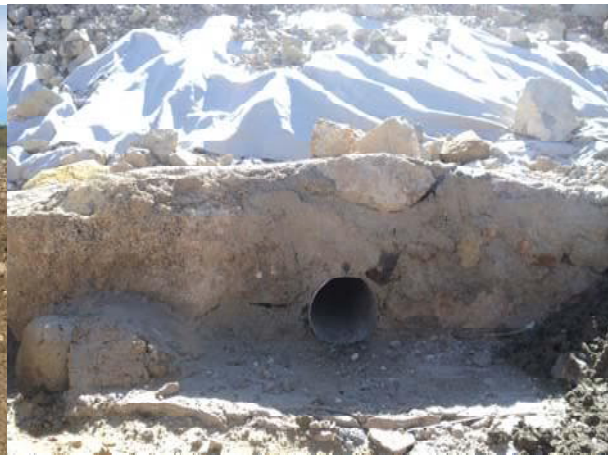
Figures 3 et 4. Examples of treatments with drainage trenches and spurs.

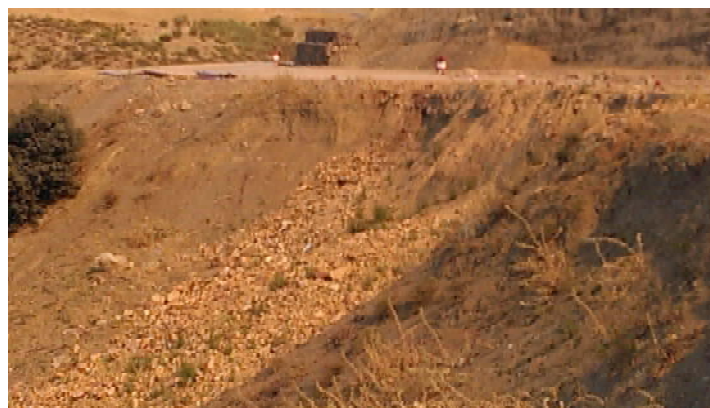
Figure 5. View of the road and the sliding before rehabilitation

120 m of the CW25 road, in the Ouarsenis mountains in the south of the Ain Defla willaya (department), slid after a heavy rain event (figure 5). Short-term decision was to reduce the width of the road. But a long-term solution was mandatory to prevent the extension of the instability in the slope and a cut, out of service, of the whole road. This road is vital for the villages of the valley, for example, for the children to go to school with the bus.

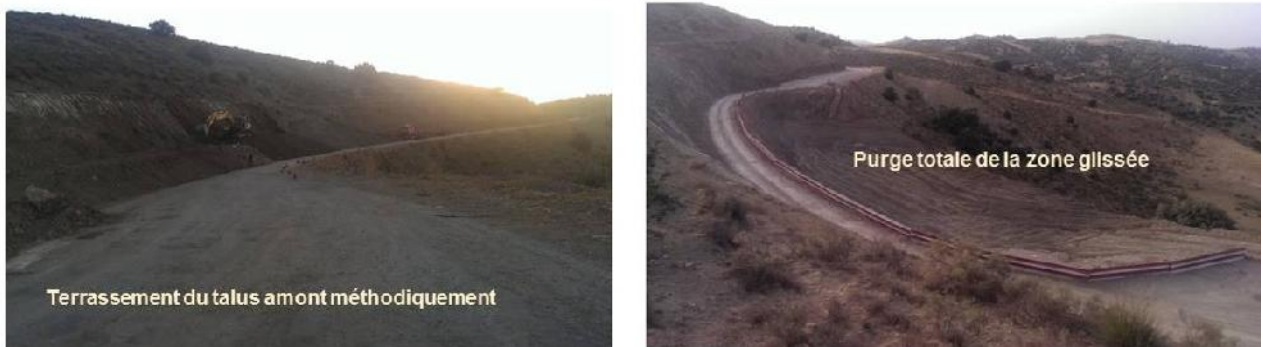
Figure 7. Widening of the road uphill and removal of the slid materials

Figures 7 à 11 illustrent les différentes phases de la construction du site

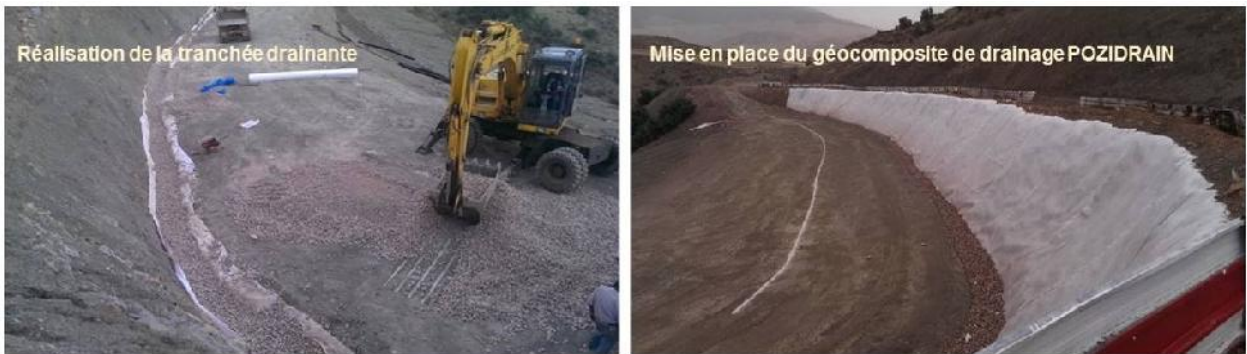
Figure 8. Water management with drainage geocomposite and drainage trench

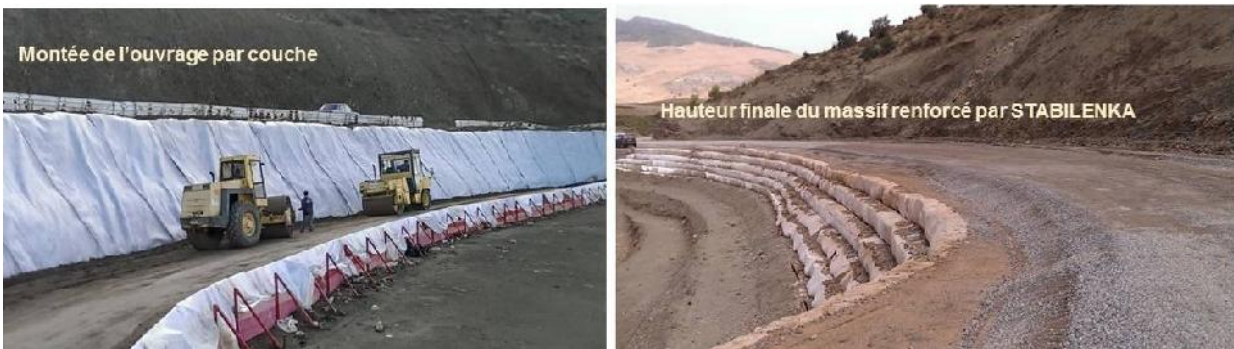
Figure 9. Building of the GRS

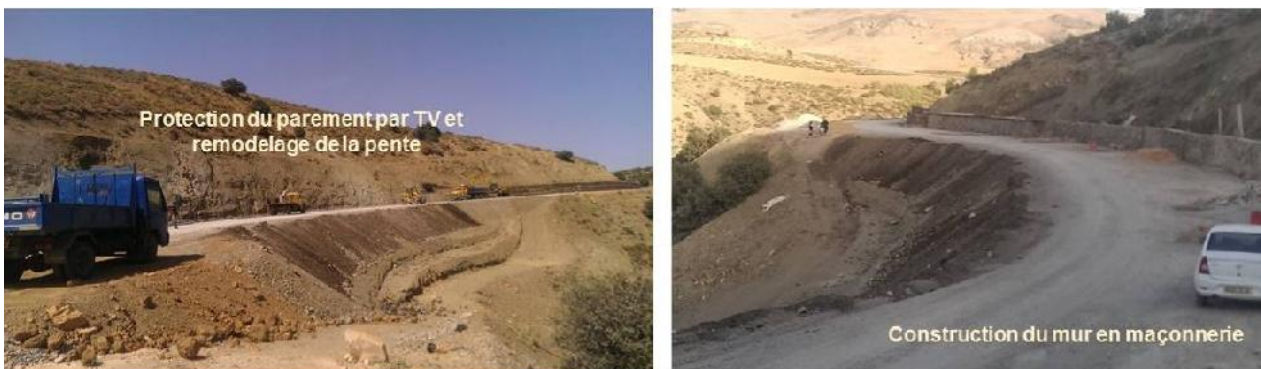
Figure 10. Protection of the slope against UV downhill and building of the masonry wall uphill

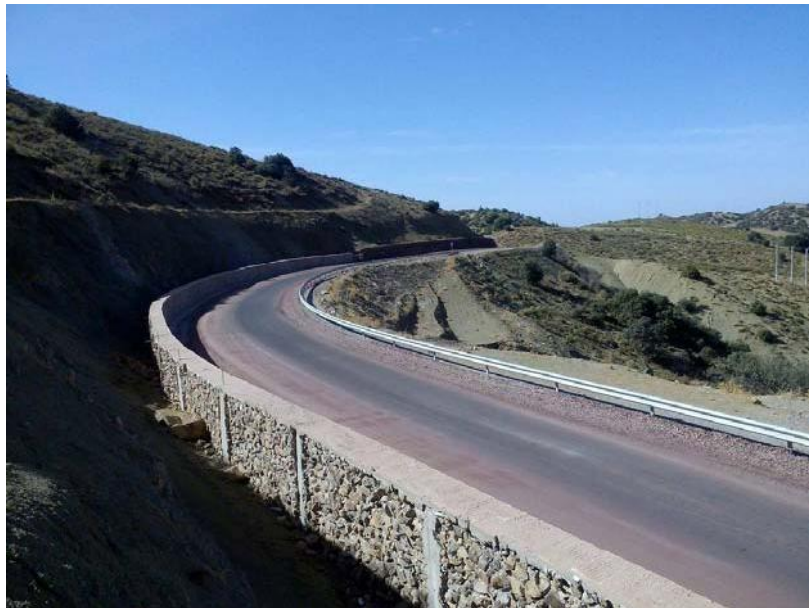
Figure 11. View of the finished project

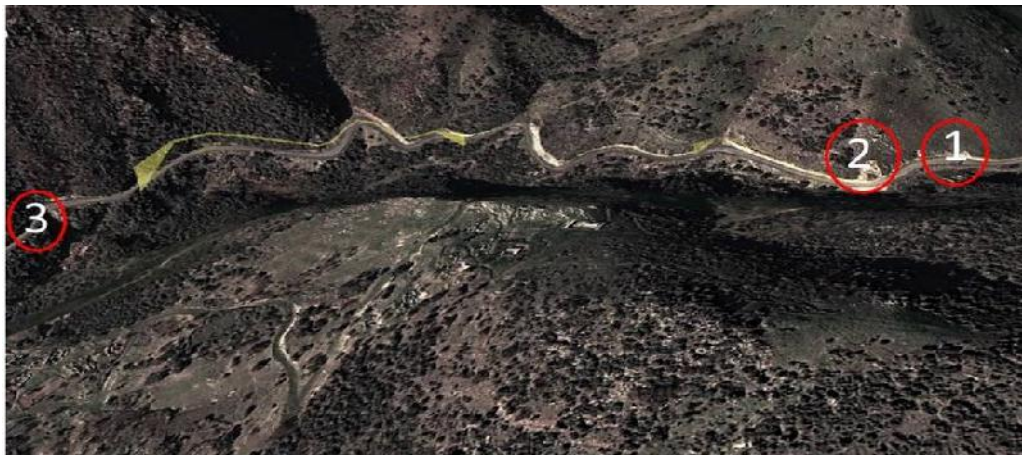
Figure 12. 3D View and position of the different slidings along the RN66 Road

During a former rehabilitation of the asphalt layer, ponctual earthworks have been done to allow heavy machines to circulate. These works combined with a lack of management of the drainage systems lead to several localized sliding along the road. We present here the treatment of the sliding n°2 (figure 12)

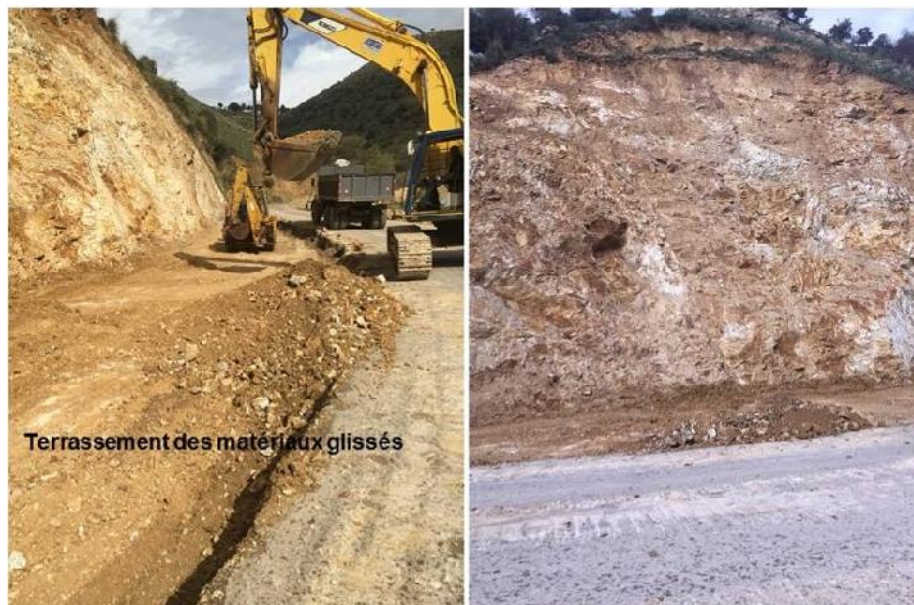
Figure 13. Removal of slided material and levelling

Figure 13 to 15 show the different phases of the construction

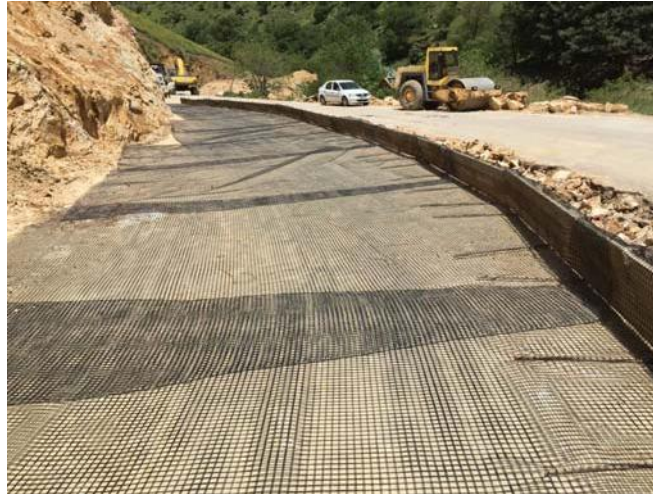
Figure 14. Construction of the reinforced slope with Fortrac Geogrid, layer by layer

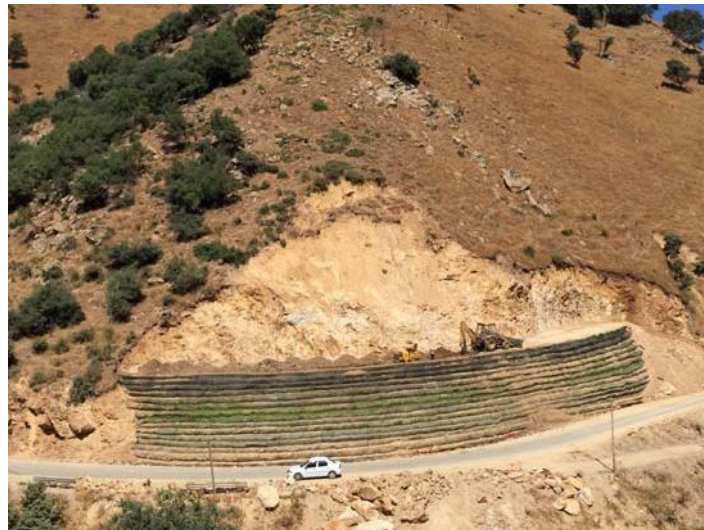
Figure 15. Construction of the reinforced slope with Fortrac Geogrid and compacted material

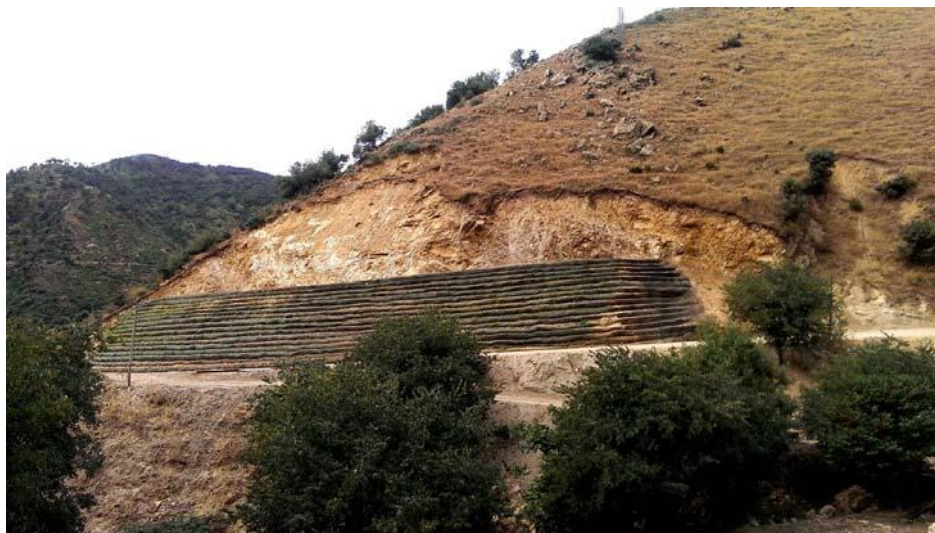
Figure 16. Earthworks completed – start of the greening of the facing

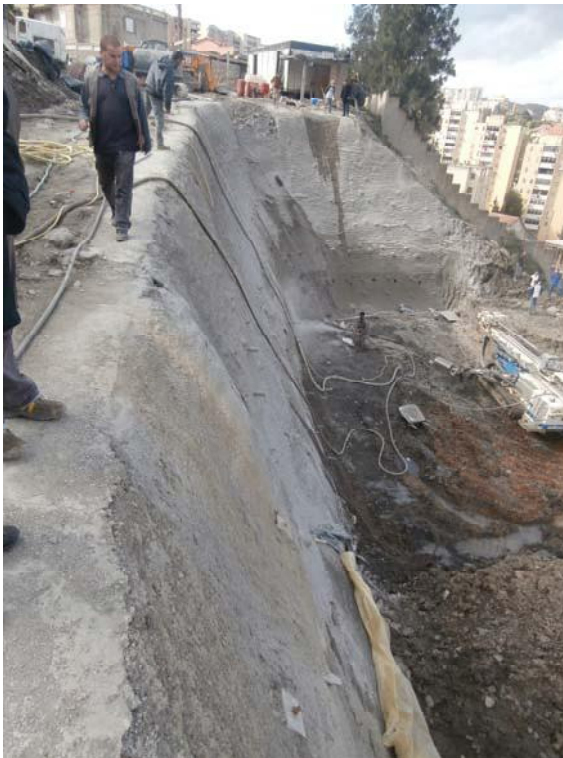
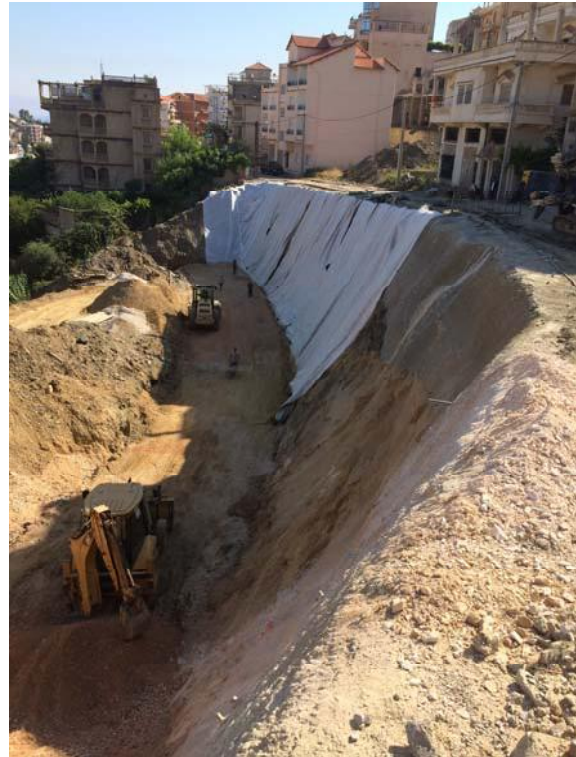
Figure 16. Anchorage and jet grouting of the excavated sliding surface and then implementation of a drainage géocomposite

Figure 16 to 18 shows the different steps of the project until the actual state. No artificial vegetation has been applied but the facing is getting greener and greener with the colonization by natural vegetation.

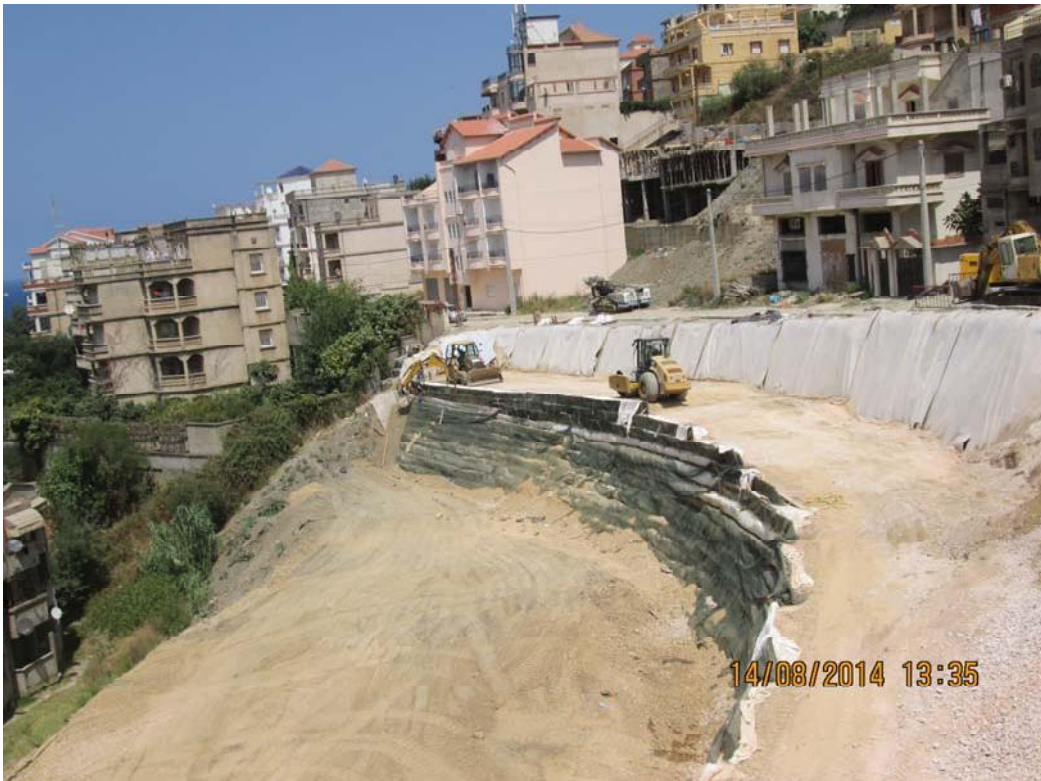
Figure 17. Building of the Geosynthetic-Reinforced Soil, layer by layer, filled by compacted material

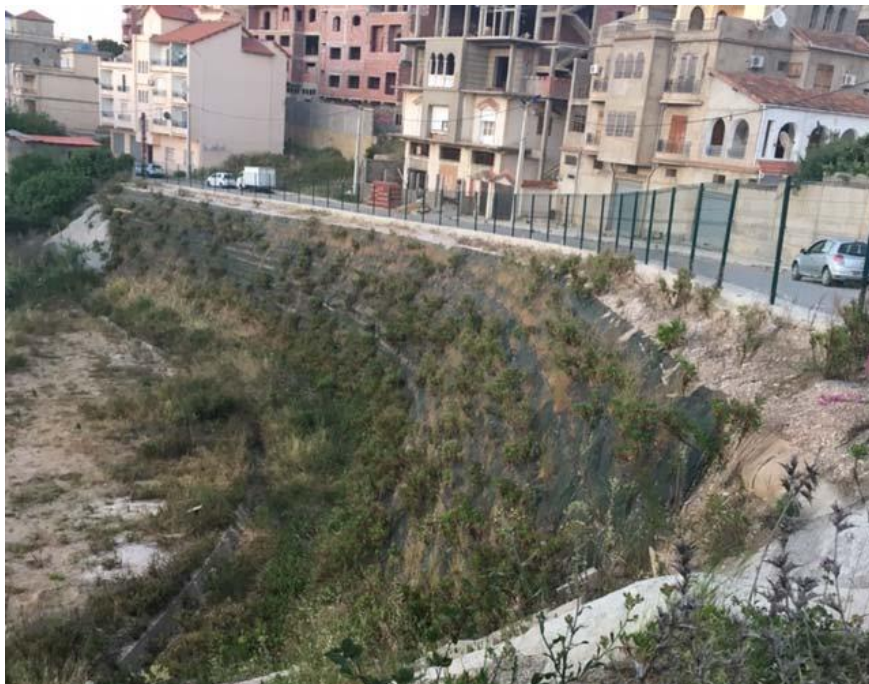
Figure 18. View of the GRS 3 years of the construction. Natural greening of the facing and no cracks on the street uphill
